CARR-1052

4101 Main Street  
Lineboro

**Maryland Historical Trust**  
**State Historic Sites Inventory Form**

historic Oliver F. B. Wentz Farm

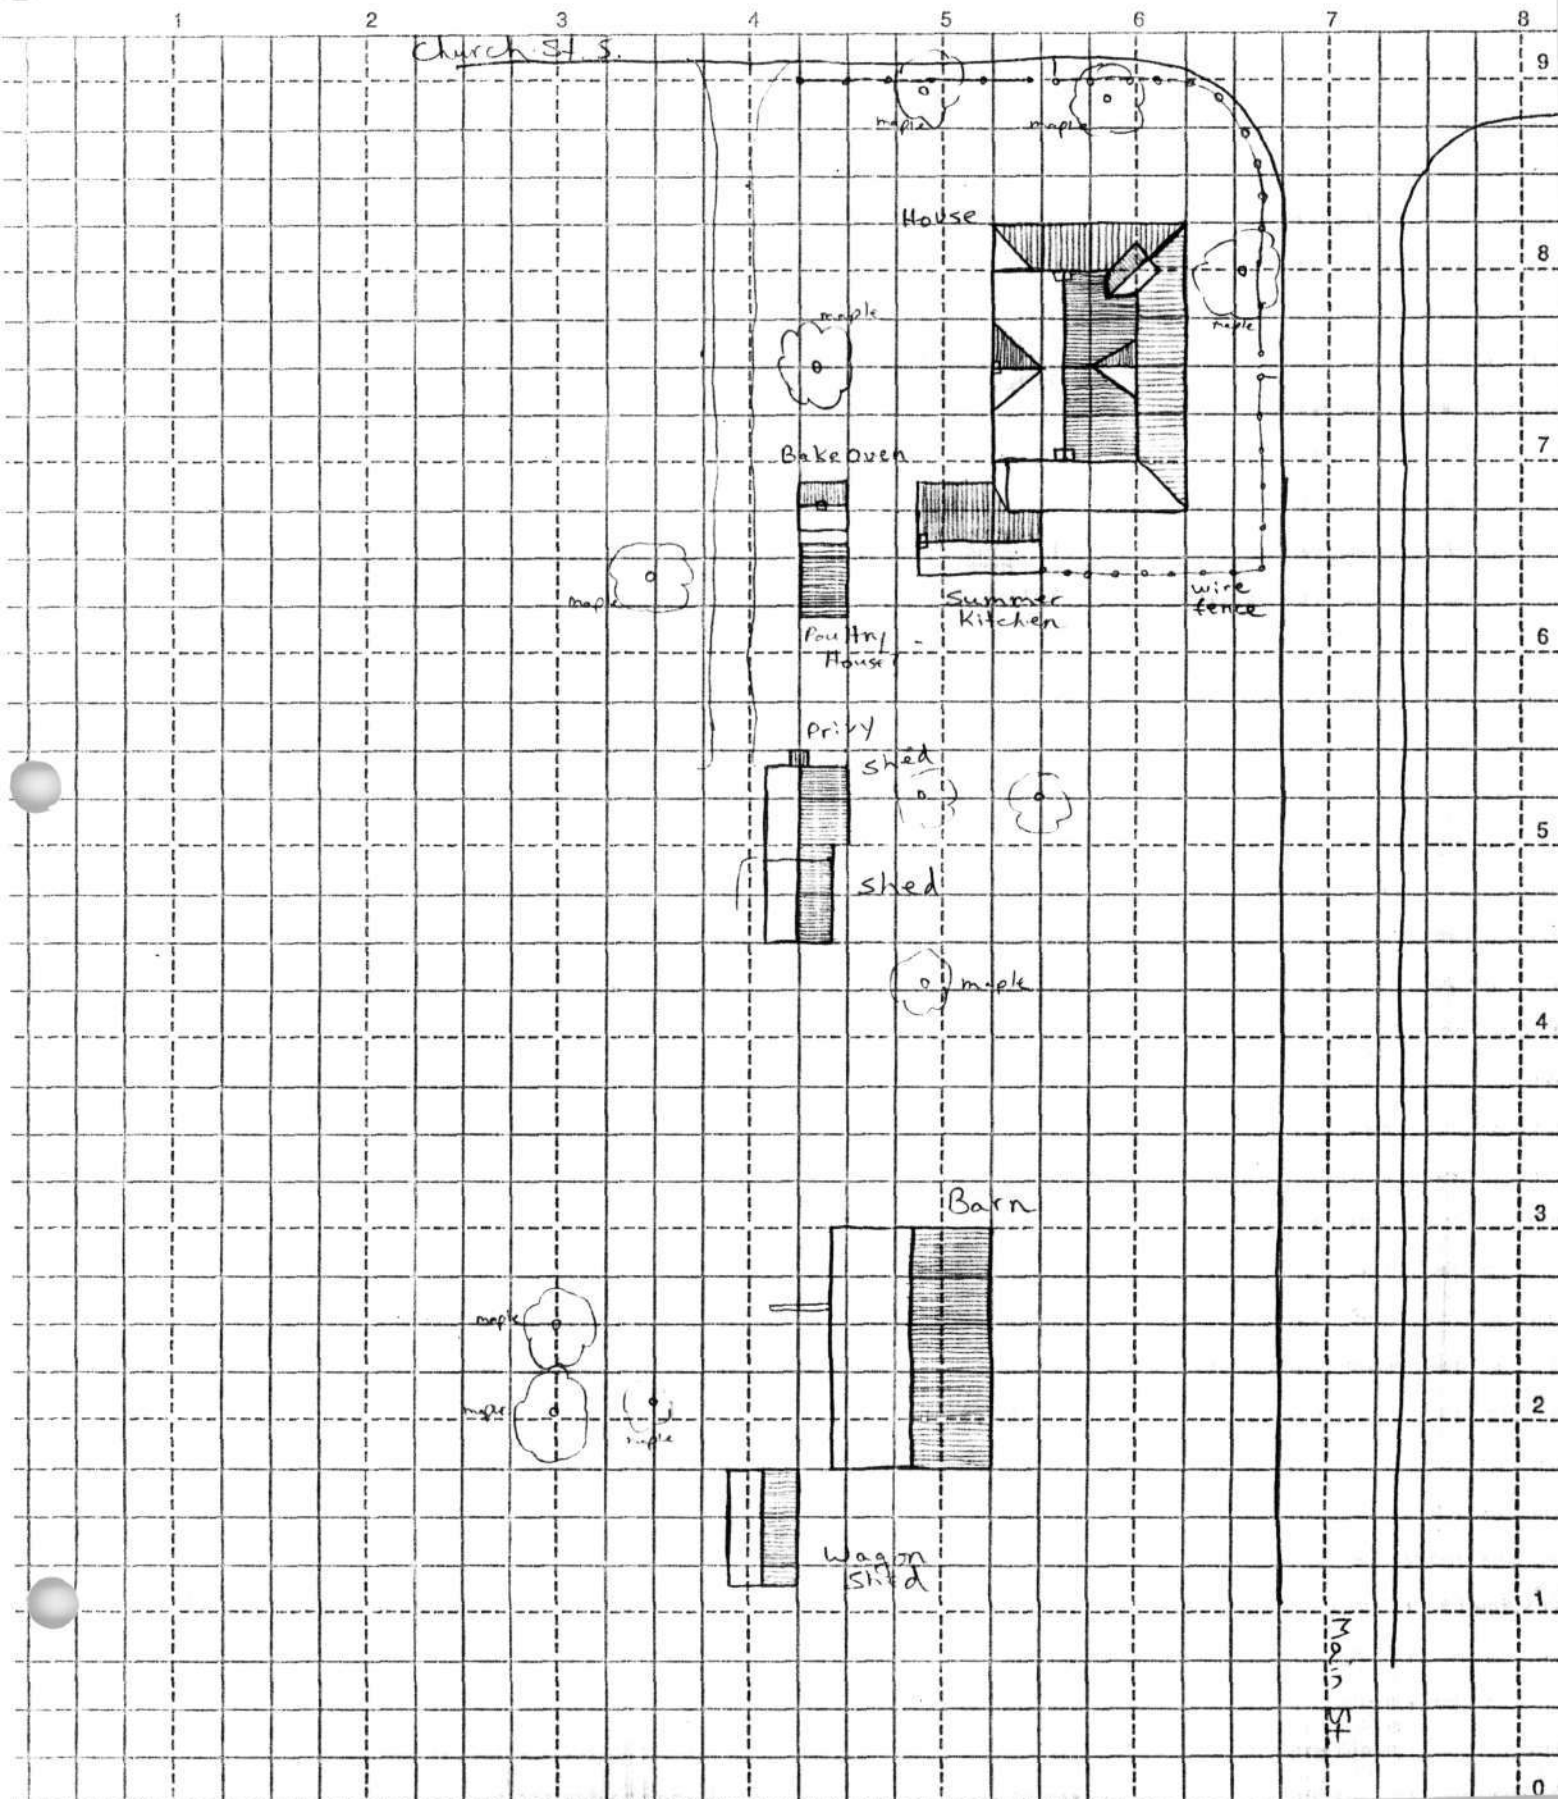
Site Plan

4101 Main St. - Lineboro

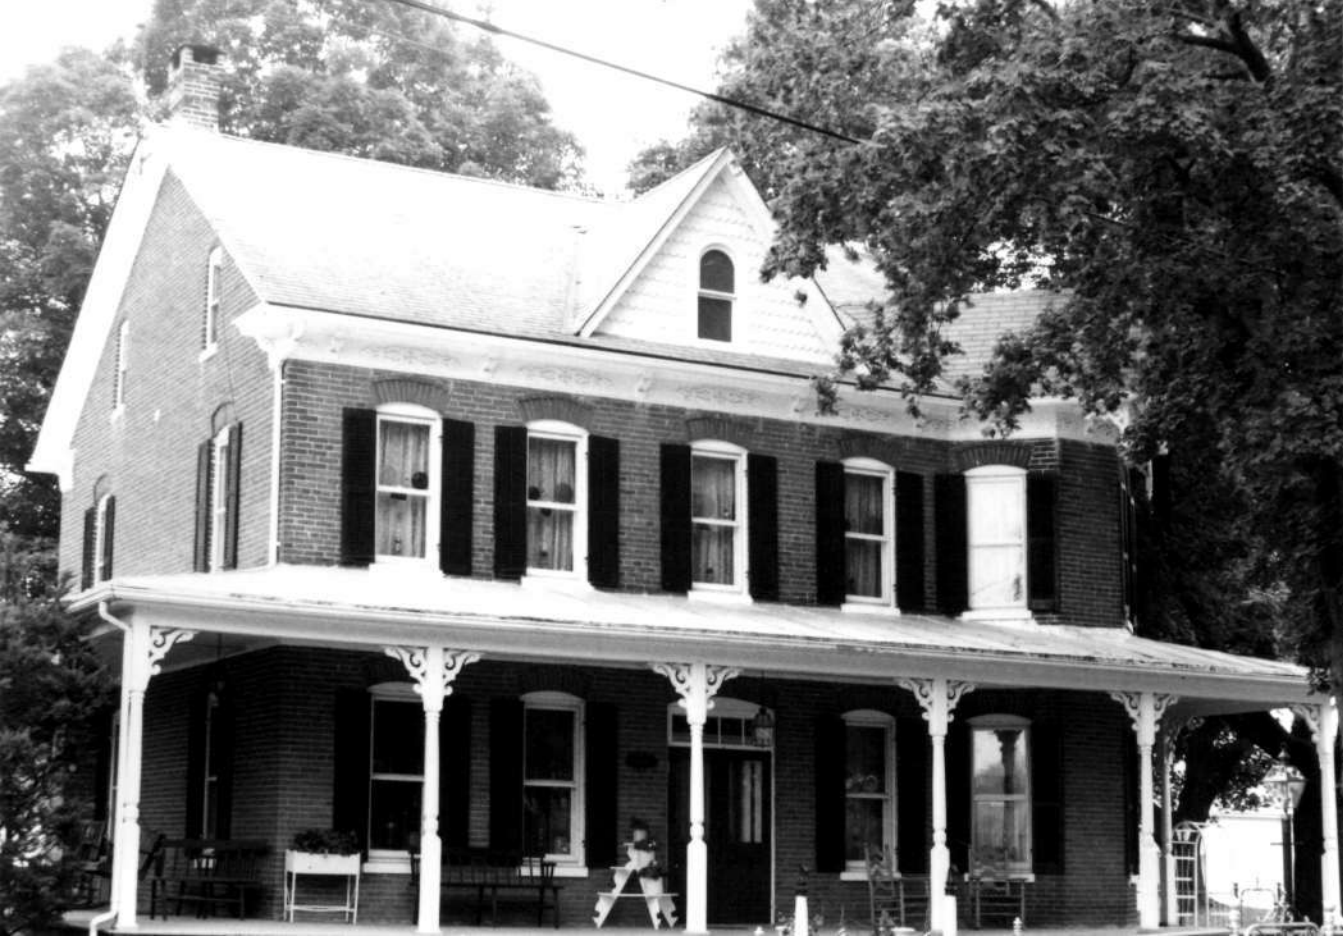
1/6

Neg. loc.: Maryland Historical Trust  
house - north-east; north-west elevations

There is a one-story hip roof porch that wraps around both the east and west sides. It has turned posts, jigsawn brackets and a standing-seam metal roof. The second story has four typical 1/1 sash, plus a typical 1/1 sash in both the northeast and northwest elevations of the turret. The bracketed cornice has jigsawn trim in the frieze. There is a central gabled wall dormer that has wood shingles with clipped corners and a segmentally-arched 1/1 sash. The turret has a gable roof with a northwest-to-southeast-running ridge. The projecting corners of the turret have jigsawn brackets with drop pendants. The tympanum has clipped corner shingles and an oculus.

The west elevation has the turret to the northwest with a 1/1 sash in the northwest elevation, as stated before, and in the southwest elevation of both the first and second stories. The first story also has a typical 1/1 sash set south of the turret and a typical 1/1 sash set just north of a door that is in the south bay. This door has one light over two panels. There is new glass in the transom, and it is segmentally arched, identical to the windows. The door is set in a bullnose frame. The details of the porch on the west elevation match those on the north elevation. The second story has a 1/1 sash in both the north and south bays. There is a tie rod at the attic floor level. The gable end has two narrow 1/1 sash in bullnose frames with wood sills and segmentally-arched lintels. The cornice has returns. The raking eave has a bed mould that appears to consist of two ogees.

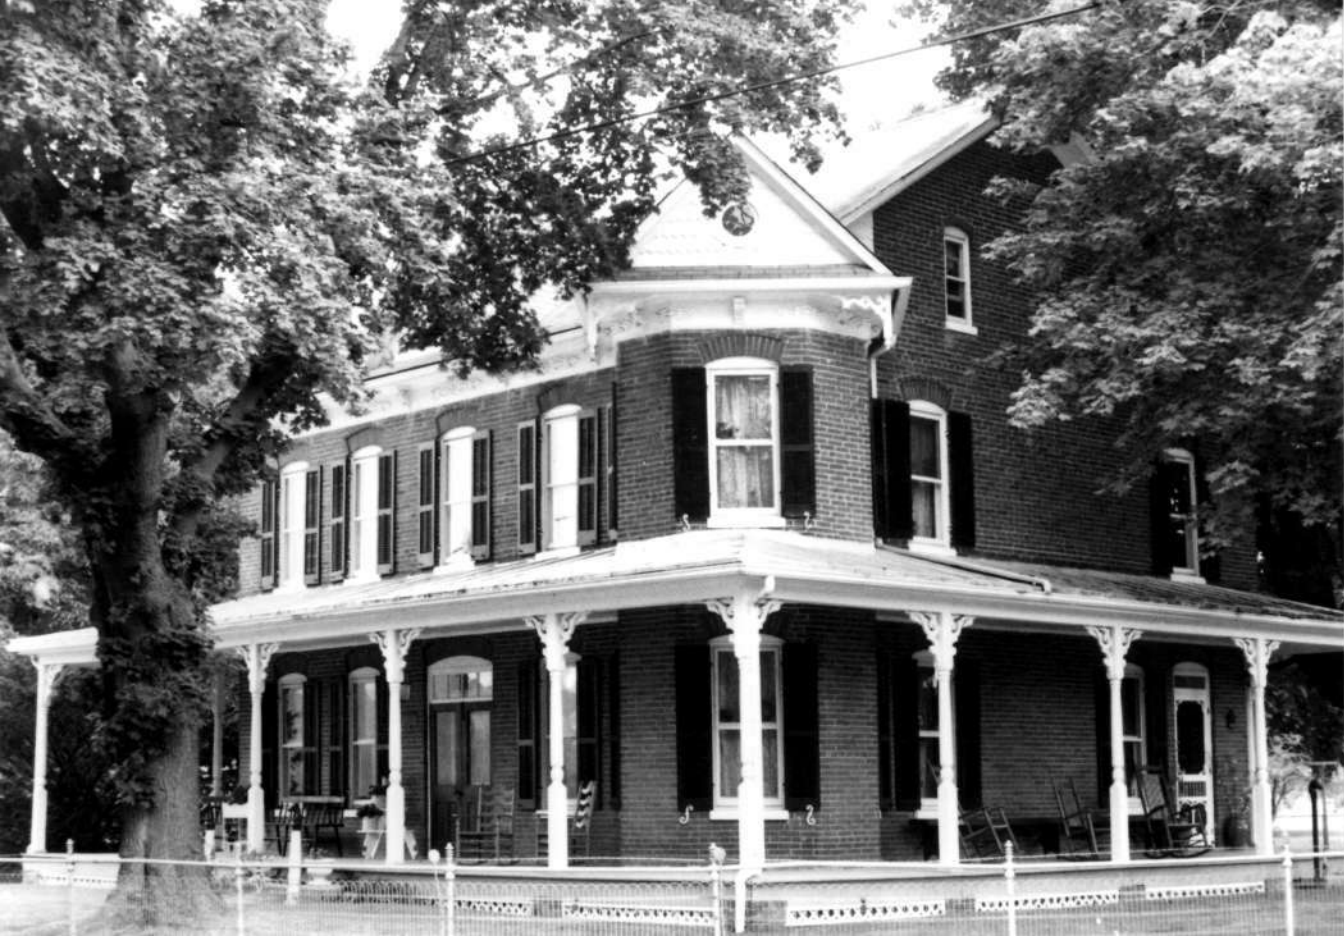
2/6

House-northwest & southwest elevations

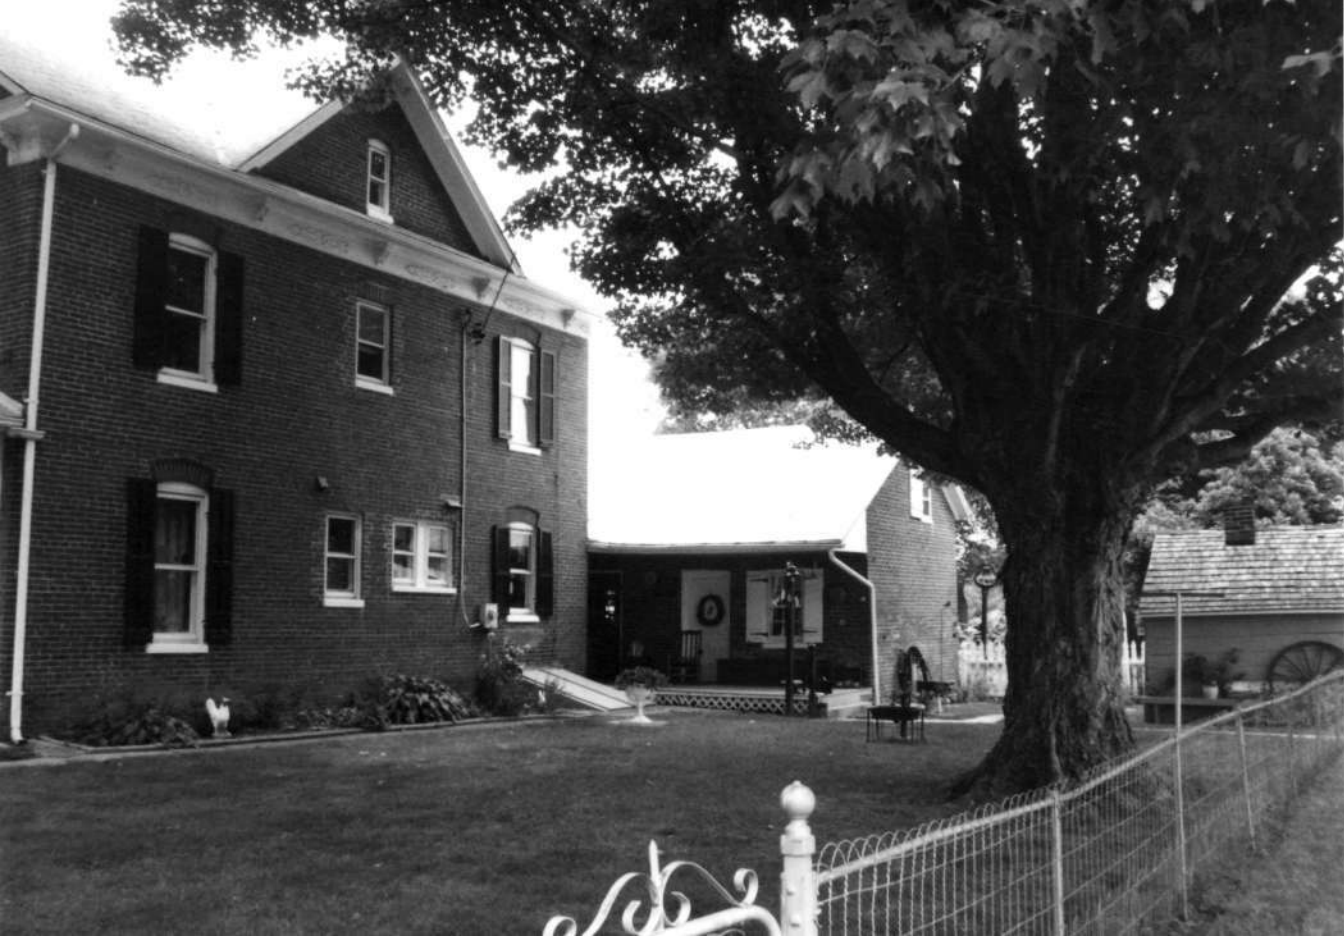
House, Summer Kitchen, bake oven -  
Southwest &  
Southeast

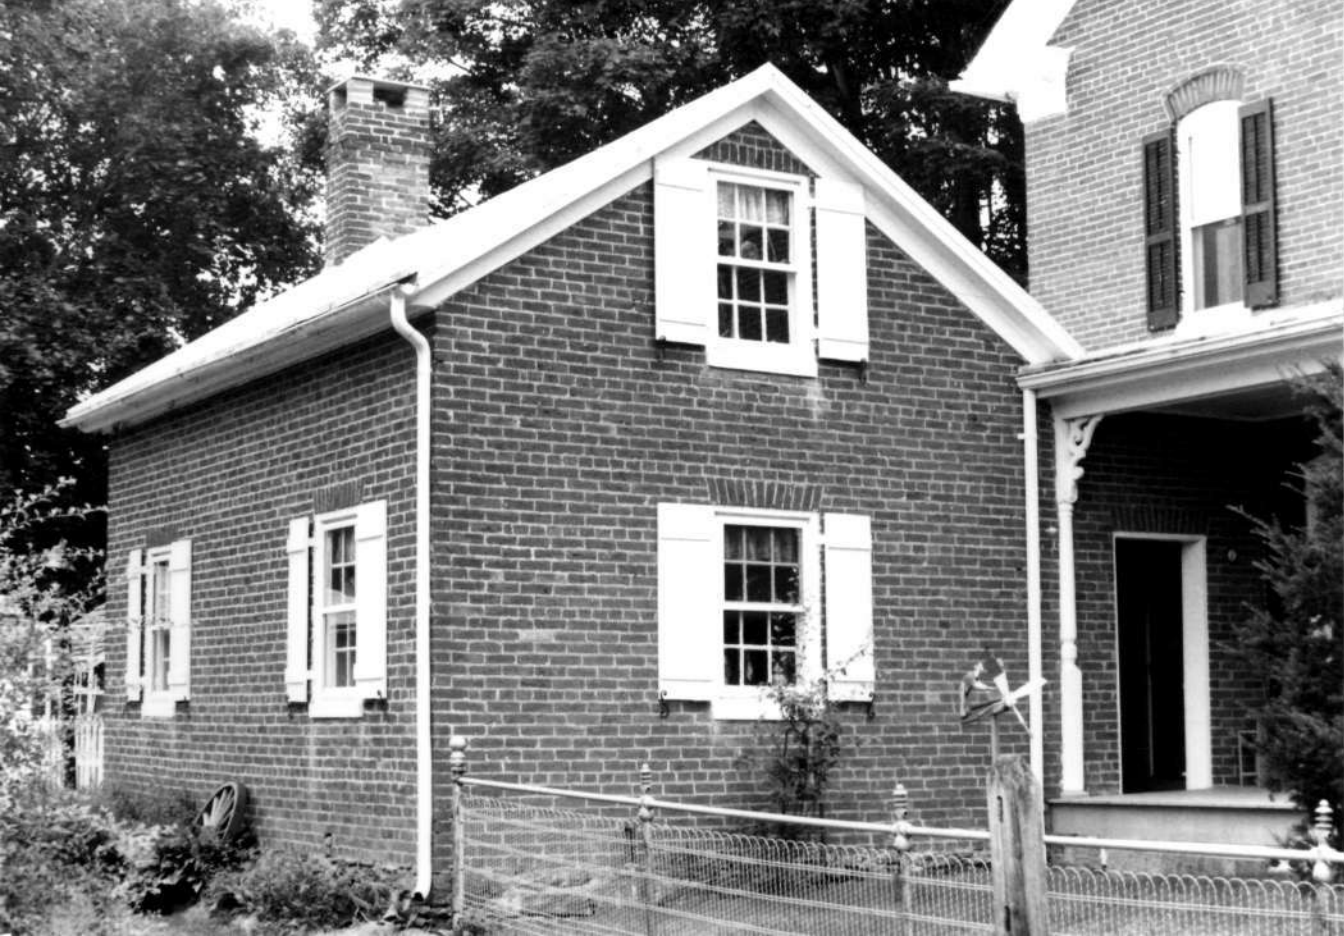
Oliver F.B. Wentz Farm  
4101 East Main Street - Lineboro  
Carroll County, Maryland  
Photo: Kenneth M. Short  
Date: Aug. 1994  
Neg. Loc.: Maryland Historical Trust  
Summer Kitchen - northeast and  
northwest  
elevations  
4/6

The summer kitchen is a three-bay by one-bay, 1½-story structure with a rubble stone foundation, 6-to-1 common bond brick walls and a gable roof with a north-south ridge and standing-seam metal. The north elevation has two narrow vents above the stone foundation and a 6/6 sash in the first story. This window has a wood sill, a beaded-interior-edge frame, a splayed brick jack arch, and new shutters. The gable end is identical to the first story, except that it has a straight brick jack arch. The raking eave has a board with a broken field.

The west elevation has a door set to the north with nine lights over two panels. The panels have sunk fields and bolection mouldings. The doorway has a beaded-interior-edge frame and a splayed brick jack arch. The center bay has the same doorway, but the door has one boarded-up light over three panels with sunk fields and no panel moulds. The south bay has a typical 6/6 sash with beaded-edge vertical-board shutters on "T" hinges. There is a cantilevered porch roof on the west elevation and an interior brick chimney with a corbelled cap on the south.

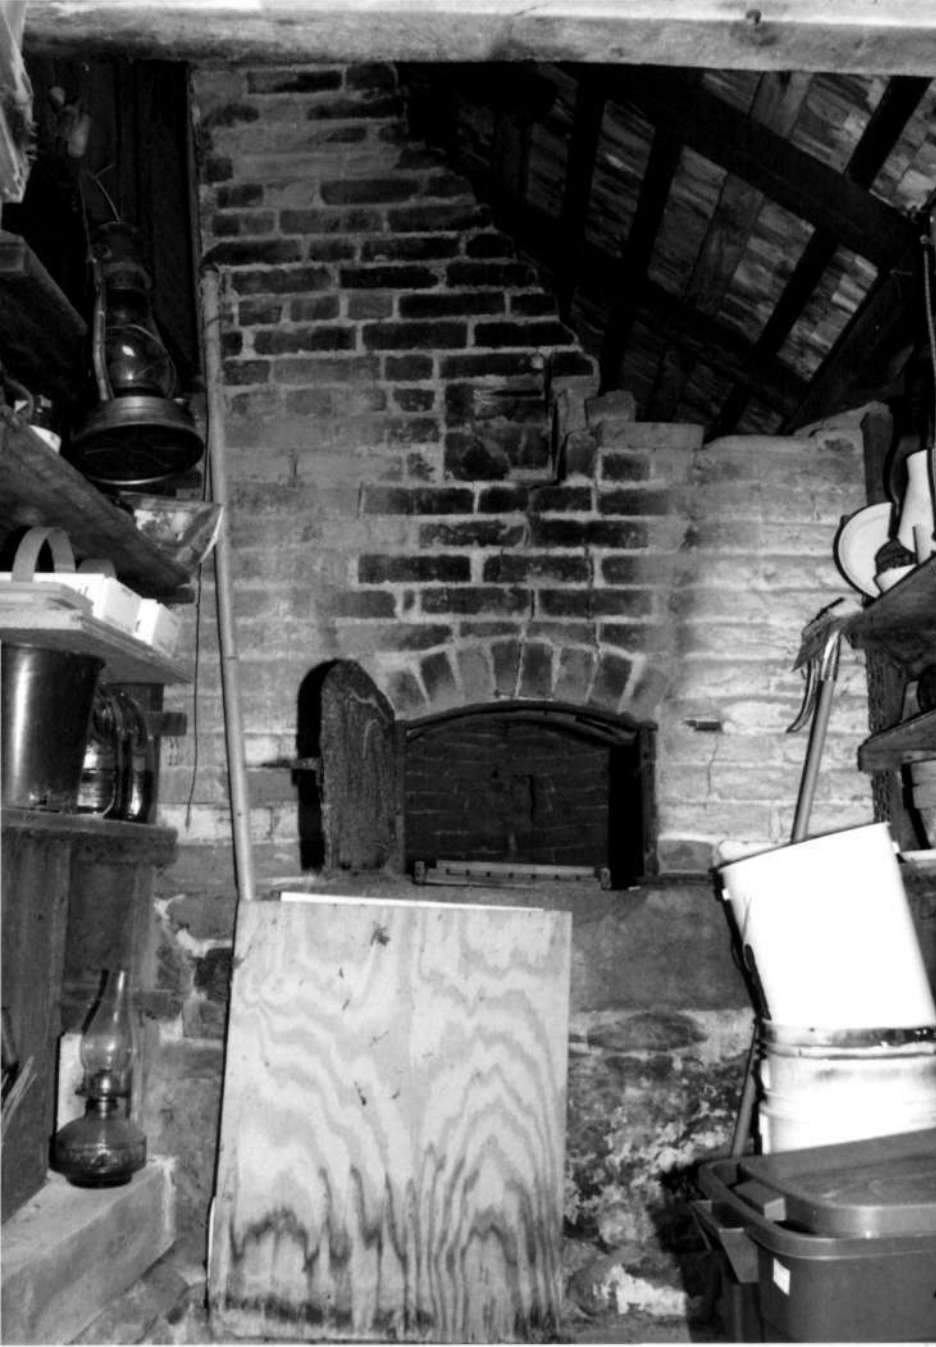
Bake oven interior - view southeast

About 10 feet south of the summer kitchen is a combination smokehouse and bake oven. It is a one-story structure with a gable roof that has a north-south ridge and wood shingles that are about eight years old. It has a rubble stone foundation. There is a brick chimney in the center of the building. The north elevation is two bays and has vertical-board siding. The east bay has a beaded-edge, vertical-board door to the smokehouse and the west bay has beaded-edge, vertical-board double doors to the bake oven. The west elevation has flush horizontal-board siding. On the south elevation, the stone foundation is higher in the west bay and has a clean-out opening in it. There is a corner board, and the horizontal-board siding is nailed with cut nails. The east bay, however, has tongue-and-grooved, vertical-board siding. This siding is also used in the gable end. The east elevation also has tongue and grooved vertical-board siding. The bake oven has a stone lower section with brick on the upper portion. There is a semi-circular brick-arched opening with a metal frame on the north side that opens to the oven. The metal door is a recent replacement. Just inside the opening on the floor of the oven is a clean-out, or hole, in the floor. There is a flue at the rear or south end of the bake oven. The bake oven has a squirrel-tail flue that runs on the outside of the oven from the rear or south up to the north and then the flue runs upward and is corbelled over to the east. The north side of the front of the flue has an opening. The east side of the structure has the smokehouse. It is built of sawn lumber and has beams running east-west. These beams contain metal hooks on which to hang the meat. The rafters are also sawn. There is a brick wall on the west set on top of the stone foundation for the bake oven that divides the smokehouse from the bake oven proper. On top of this wall is a vertical-board wall. The south end of the smokehouse has a stone fire pit with an iron grate on top of it.

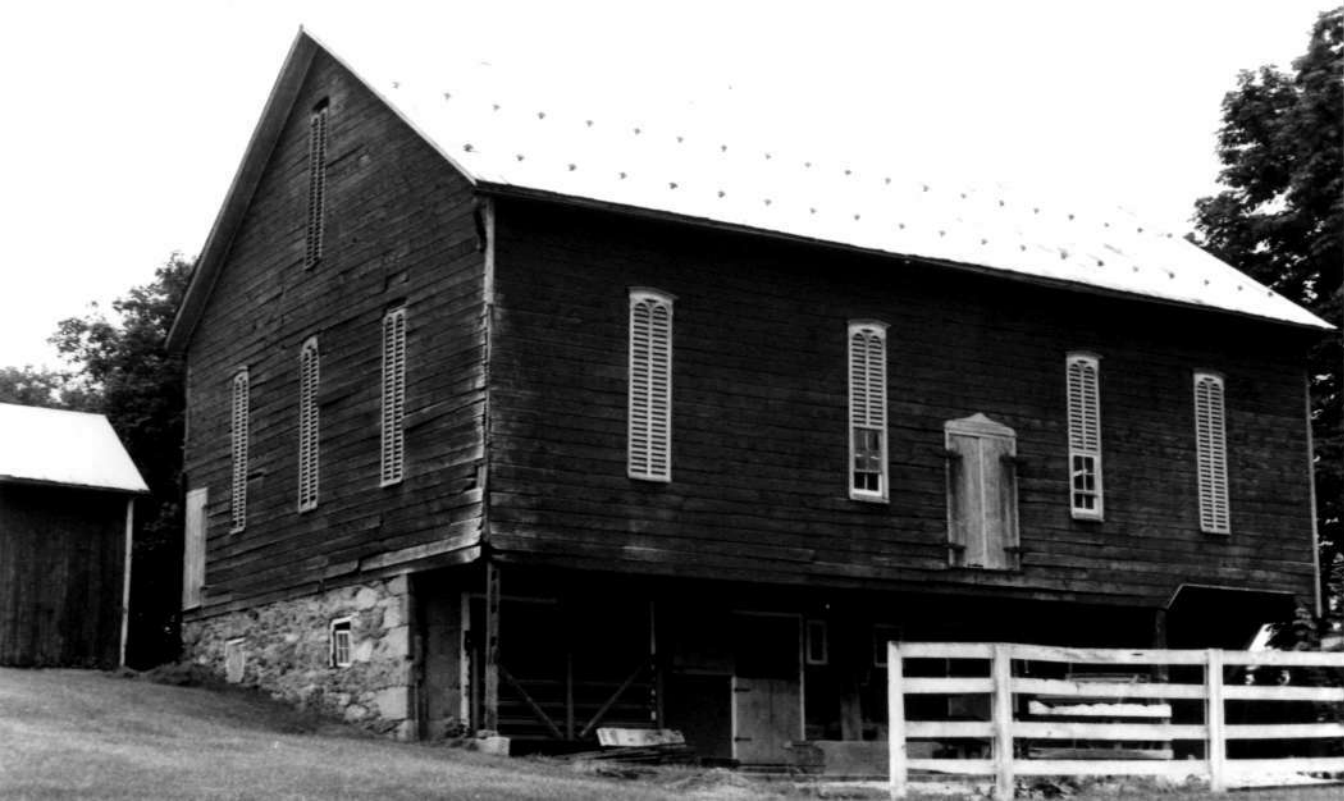
Oliver. F.B. Wentz Farm  
4101 East Main Street - Lincolnton  
Carroll County, Maryland  
Photo: Kenneth M. Short  
Date: Aug. 1994  
Neg. loc.: Maryland Historical Trust  
barn - east and north elevations

About 40 feet east of this shed is a bank barn with a north-facing forebay. This barn was originally part of the farm, but has since been broken off and is owned by someone else. The barn is a five-bay by three-bay, two-story structure. The barn has a rubble stone lower story, horizontal novelty siding on the upper story, and a corrugated metal gable roof with an east-west ridge. On the north elevation the lower story has, from east to west, a wide new opening, a vertical-board dutch door on strap hinges, two four-light sash, another vertical-board dutch door on strap hinges, and a pair of vertical-board wagon doors on strap hinges. The wagon shed on the west end is integral with the barn. The upper story of the north

elevation has a tall vent on each end, then a vent with a 4/2 sash set at the bottom of it, set inside of each end bay. The center bay has vertical board double doors.

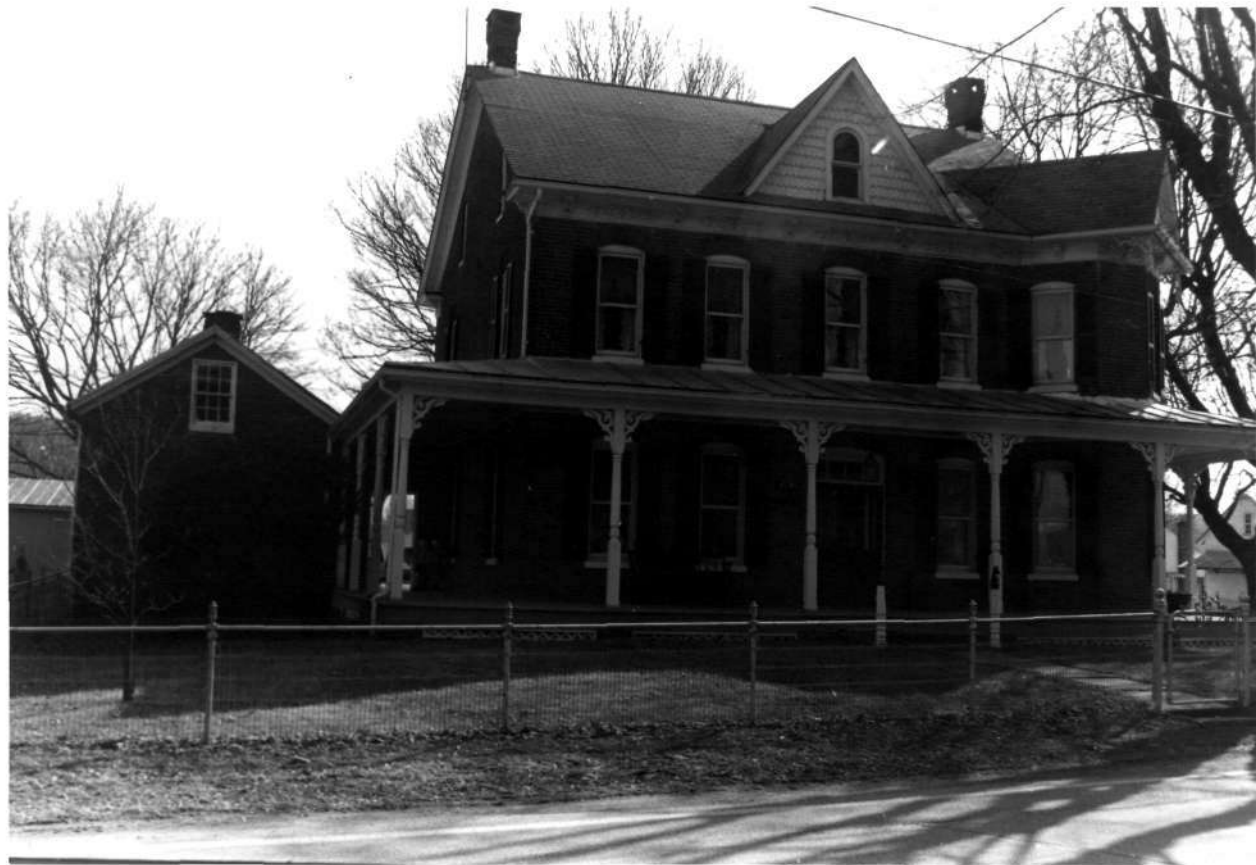
1. CARR-1052
2. Carroll County, Maryland
3. Joe Getty
4. February 1985
5. Md. Historical Trust, Annapolis, Md.
6. west elevation
